Report No.: 2018032918272788

Report Date:17 September 2018

GENERAL INFORMA	TION	
Inspection Type	Normal inspection	
Buyer Name		
Vendor Name		
P.O. Number		
Item Number	170715/170716/ AMS118-1/ AMS108/ AMS109	
Product Name	Hair Brush	
Service Performed	FRI	
Inspection Date	Sep. 17. 2018	2014/19/17
Inspection Location	Ningbo, Zhejiang	
Ref. sample(s) Available	No

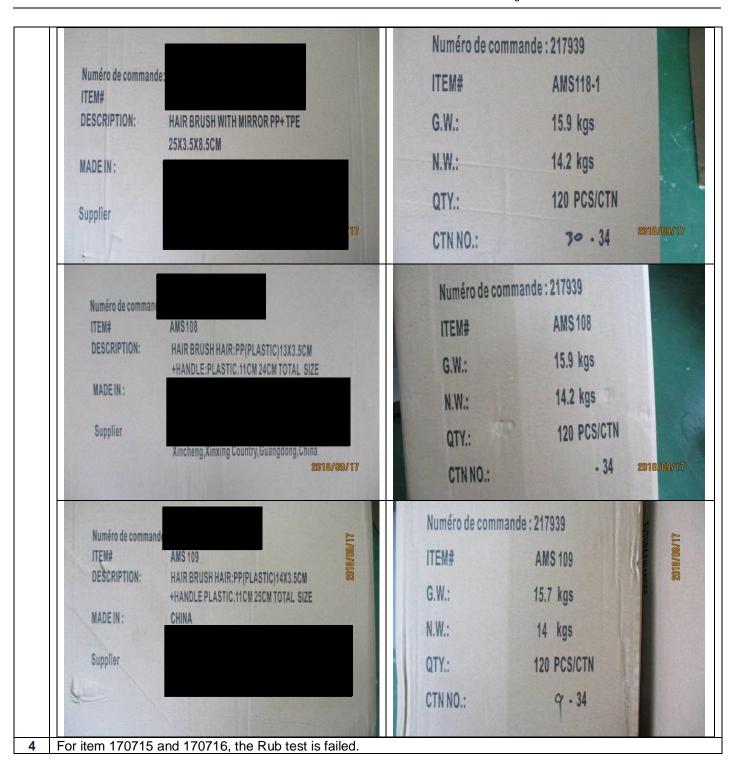
RE	MARKS
1	Actual shipping quantity was 20400pcs instead of 20000pcs.
2	98.24% of the total quantity was finished and packed.
3	Actual found shipping mark different with spec, detail see below pictures.

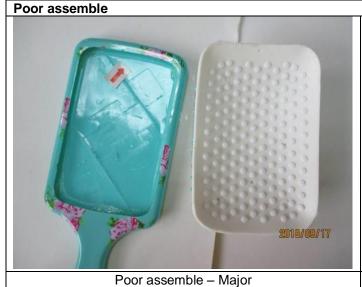
Poor assemble - Major

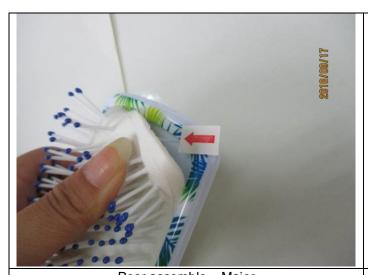
Poor assemble – Major	Poor assemble – Major			
Details of Defect Found: Style # AMS118-1 - 25%	6 Defectives	Critical	Major	Minor
Hole		0	1	0
Poor assemble		0	5	0
Poor mirror		0	1	2
Dirty mark		0	0	3
Flash mark		0	0	3
Glue mark		0	0	5
Scratches mark		0	0	1
Poor finishing	_	0	0	1

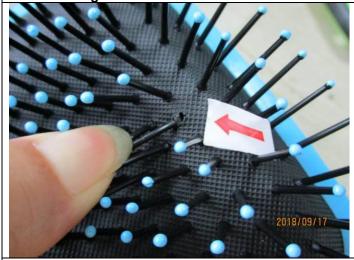
Hole - Major

Poor assemble – Major

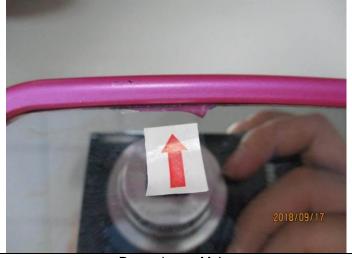
Poor mirror – Major

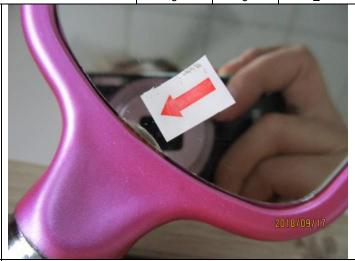
Poor mirror – Major

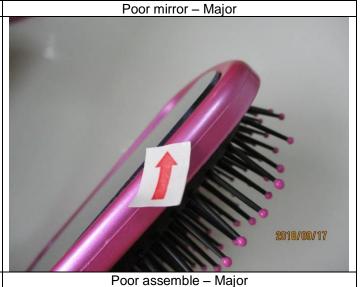
Poor mirror – Minor

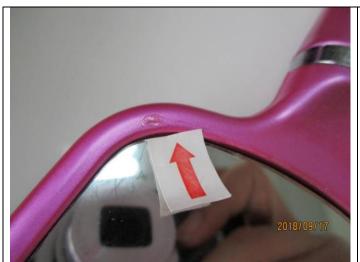
Glue mark - Minor

Poor finishing - Minor
